## Research in Graubünden

### **Rock avalanche at Piz Scerscen**

Searching for the trigger

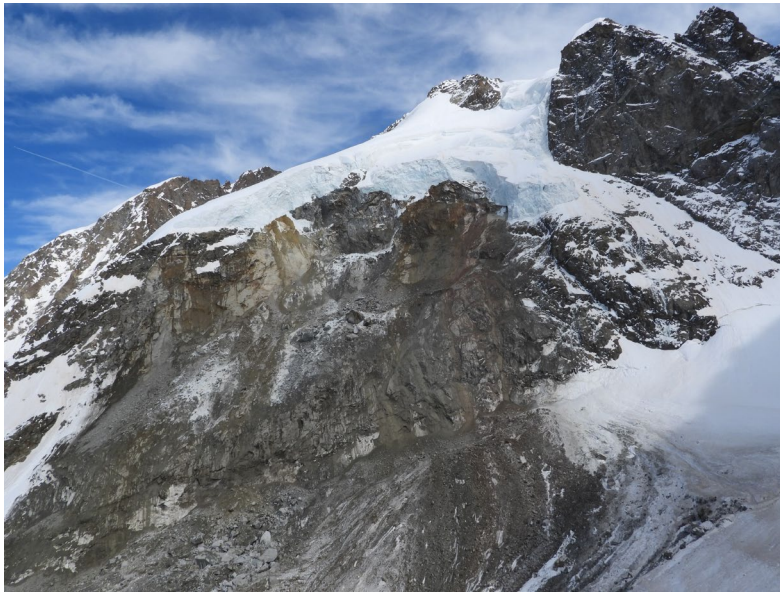
The release area on Piz Scerscen after the rock avalanche of 14 April 2024.  
Photo: Dominik Hunziker, Head of SAC Bernina Mountain Rescue.

The analyses conducted so far show that the rock structures favored the collapse. A largely continuous discontinuity had a similar orientation to the eventual sliding surface. Models suggest, however, that these zones of weakness alone were not sufficient. An additional influence must have come into play. Much points to water and ice having contributed to the rock avalanche. Several findings support this theory: glacier-specific models produced by ETH Zurich for the glacier in the release

zone indicate considerably more meltwater than usual during the two years preceding the event. Ground-penetrating radar measurements reveal possible water pathways within the glacier. Photographs taken after the collapse also document water emerging from the exposed rock face, as well as permafrost ice. Some of the water may have entered the rock through cracks, partially frozen there and created additional pressure as it expanded. The combination of zones of weakness, water and refreezing is therefore currently considered a particularly plausible explanation.
